## Engineering and Architecture Applications based on Unmanned Aerial Vehicles, UAV

F. Carvajal (a), F. Agüera (a), M. Pérez (a)

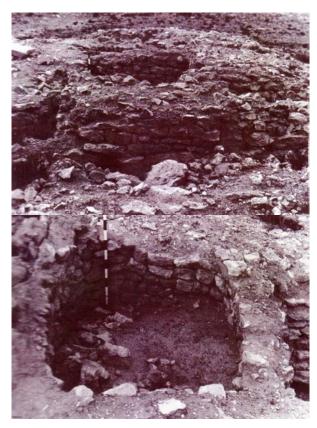
Fig. 16 Structures made of stones dug in the site.

The site was almost unaltered at the beginning of the 1970s. A group of structured made of stones were dug, in a regular disposition and interconnected one each other (fig. 17).

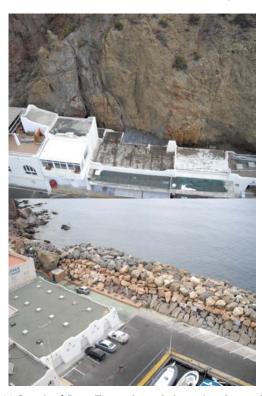
Fig. 23 San José Port. Two points of view taken from a fix helix UAV for stability talus control.

Another project to control infrastructures was carried out in the San José Port, in the province of Almería. The stability problems in the rock behind the buildings located in the proximity of the main jetty were characterized, where the accessibility was especially difficult (fig 23).
